# Research focused on low carbonation of concrete under old cement-based render

Peter PAULÍK<sup>1</sup>, Jakub GAŠPÁREK<sup>1</sup>, Michal BAČUVČÍK<sup>2</sup> and Ivan JANOTKA<sup>2</sup>

<sup>1</sup>Slovak University of Technology - Faculty of civil engineering, Bratislava, Slovakia

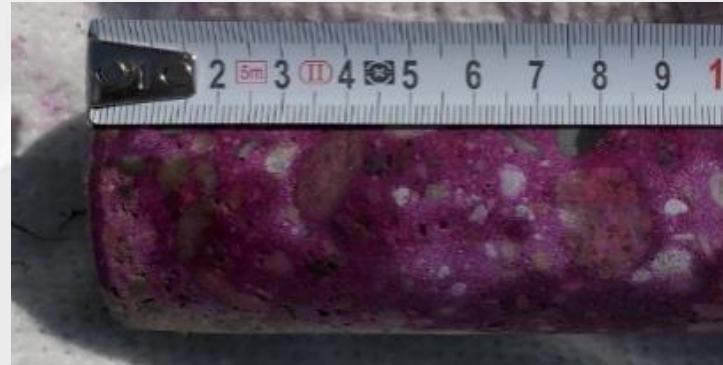
**Figure 1.** The carbonation depth of concrete at the places with a thin layer of PRC at the surface – sample selected from the measurements performed in 2018 (Bridge in Sládkovičovo).

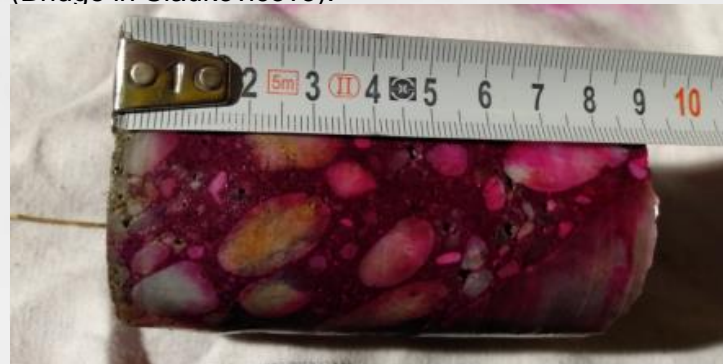
**Figure 3.** The carbonation depth of concrete at the places with a thin layer of PRC at the surface – sample selected from measurements performed in 2019 (Bridge in Rimavská Sobota).

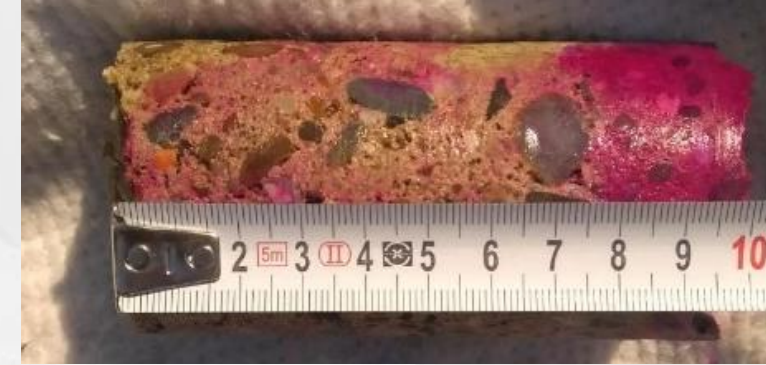
**Figure 2.** The carbonation depth of concrete at the places where the render was missing – sample selected from the measurements performed in 2018 (Bridge in Sládkovičovo).

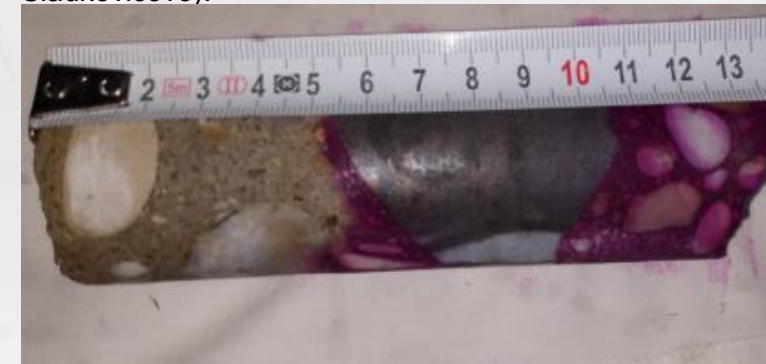
**Figure 4.** The carbonation depth of concrete at the places where this render was missing – sample selected from measurements performed in 2019 (Bridge in Rimavská Sobota).

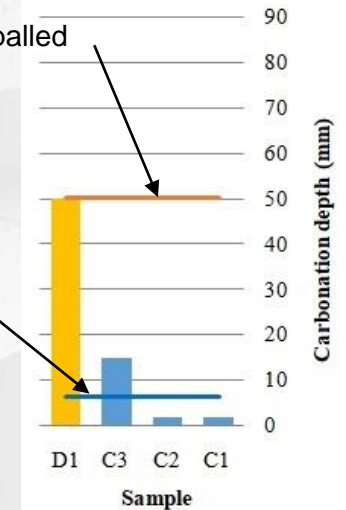
**Figure 6.** Results of in-situ measurements of carbonation depth at the Bridge in Rimavská Sobota.

In-situ investigation, as expected, showed some relationship between the permeability measured on the PRC and the carbonation depth of the underlying concrete. Most of the measured places appeared to be almost impermeable (measured results by the Torrent permeability tester were below  $0,01 \times 10^{-16} \text{ m}^2$ ) and at these places, the underlying concrete showed negligible carbonation depth (max. 2 mm) even after being exposed to XC3 exposure class for more than 100 years. In some cases, negligible carbonation was measured also in cases, where permeability results were a bit higher. It was also observed, that even a small crack (crack width below 0,05 mm) caused higher permeability results and also a higher carbonation depth at this location. The results of these in-situ measurements are presented in tables 1, 2, and 3 for different, more than 100 years old bridges.
